Pre-Purchase Inspection Report

100 Street Avenue
Town, QC H0H 0H0

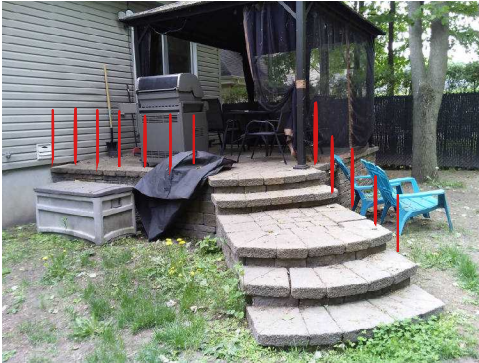
1. Deck: **Paving stone** - Safety railing missing around deck and steps, this is a safety issue that requires immediate correction to prevent personal injuries.

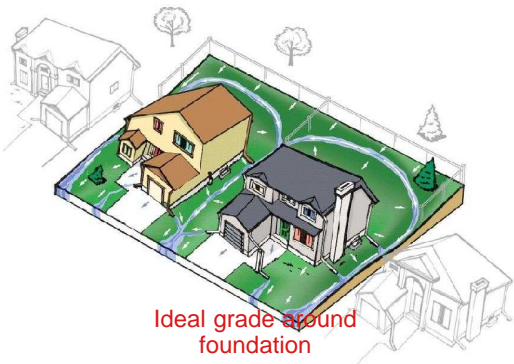
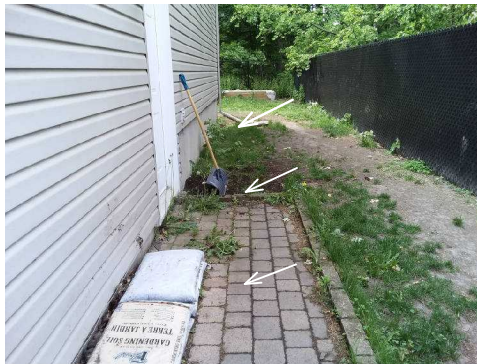
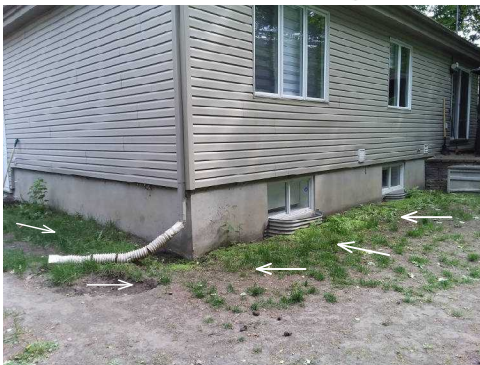
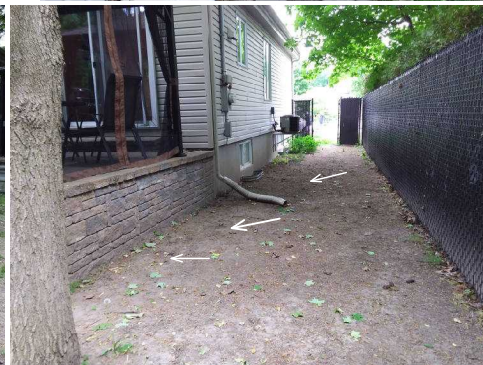
2. Grading: **Negative slope observed** - Negative grade slope noted on the Left, Right sides and rear. Immediate build up of positive grade slope (1 inch per foot for 6' from the foundation) is required to divert storm water away from the foundation and prevent water infiltration and damage to basement area.

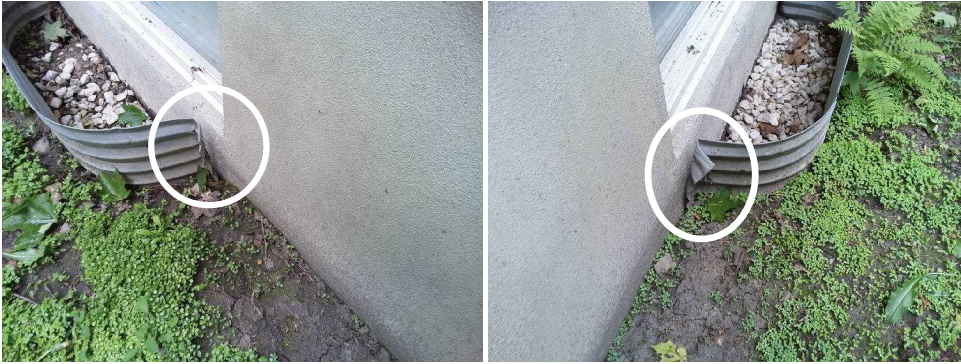
3. Window Wells: **Galvanized material** - Window well pulling off and not properly anchored to wall allowing storm water to seep into well area. Correction required.

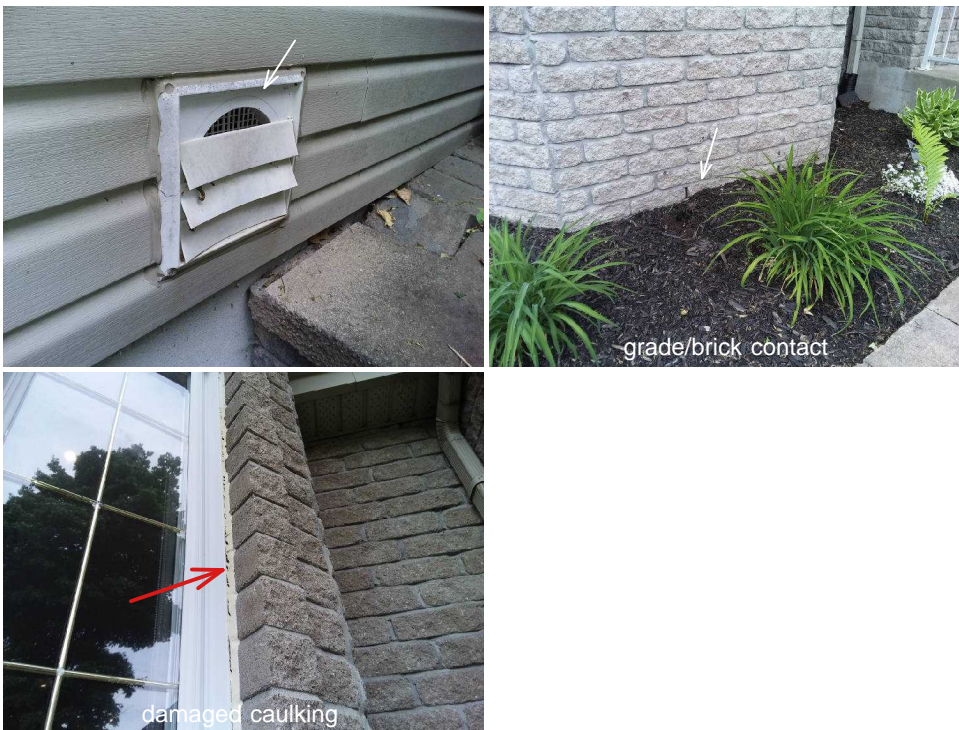
4. : All around Exterior Surface Type: **Brick veneer, Vinyl siding - Flappers - Exterior flaps found damaged.**
Repairs required to prevent water intrusion.

Brick contact with soil noted at front flower bed. This condition must be immediately further investigated / corrected by a certified contractor to prevent further damage and deterioration to the wood framing behind the walls.

Caulking is breaking up around windows. Immediate re-caulking is required to prevent further water infiltration / damage to framing behind.

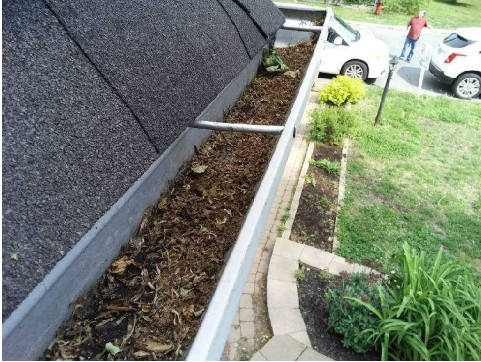
5. Gutters: **Metal - Found dirty. Immediate cleaning required fro proper storm water drainage.**

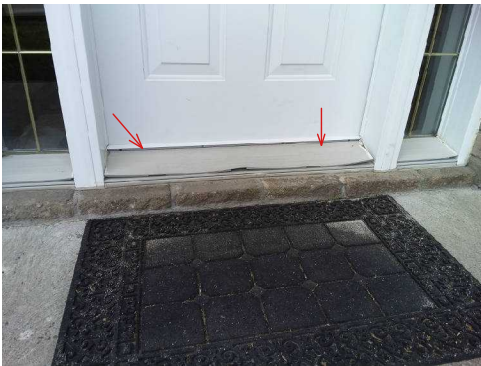
6. Entry Doors: **Hinged metal & glass - Damage to door sill observed. Repairs required to prevent water infiltration.**

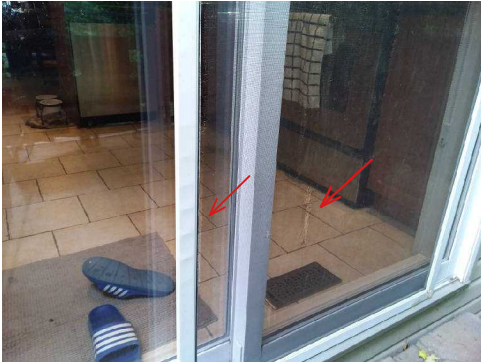
7. Patio Door: **Vinyl sliding - Screen damage / cuts noted. Repairs / replacement required.**

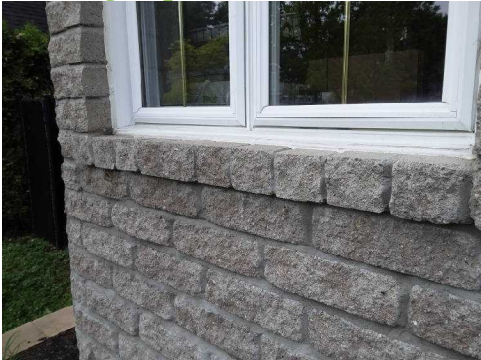
8. Window Sills: **Brick - Brick sills are prone to leak and damage. Recommend covering with a metal clad / flashing to prevent water infiltration and damage to framing wood.**

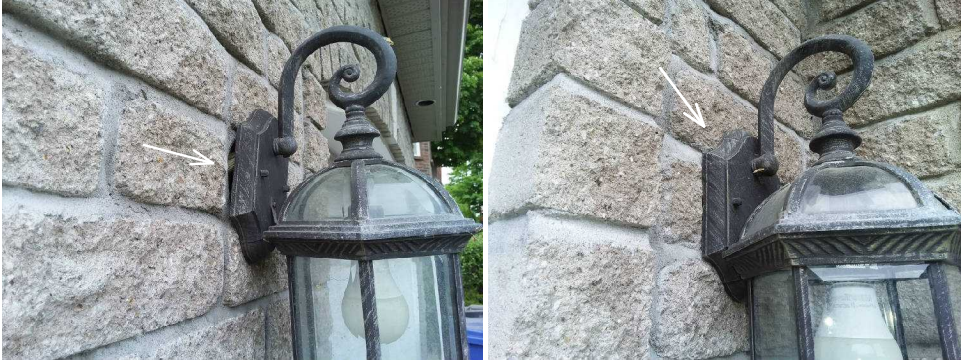
9. Exterior Lighting: **Surface mount** - Light bases not caulked (weather proofed). Caulking required to prevent water infiltration & damage to wood structure behind.

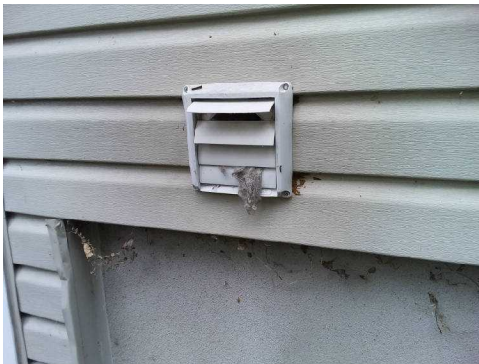
10. Dryer Outlet: **Exterior Grill** - Lint build up noted at the exterior dryer vent. This is a fire hazard that needs immediate correction.

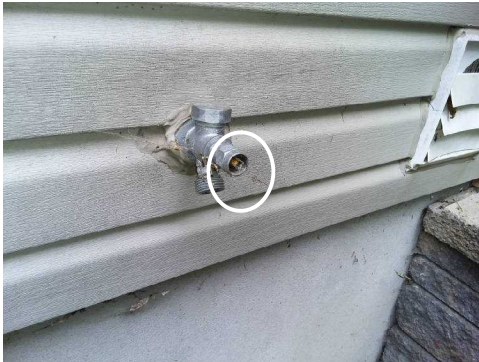
11. Hose Bibs: **Frost resistant (self draining type)** - Missing / damaged handle noted, correction required.

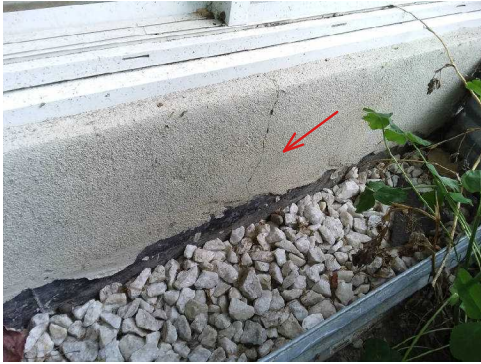
12. Foundation: **Poured concrete** - At least 1 crack noted. Immediate repairs by a certified foundation contractor is required to prevent water / insect intrusion into basement.

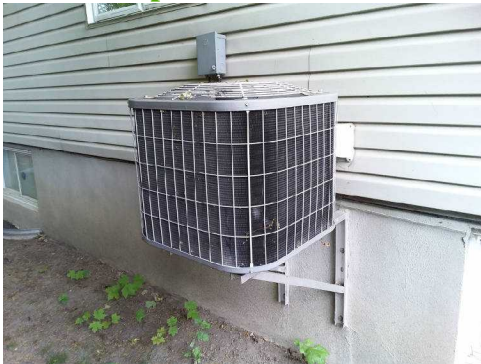
13. : Central AC AC System A/C System Operation: **Recommend replacement** - Average life of an outside A/C compressor/condenser is approx. 15-18 years. In the inspectors opinion the 17 year old air conditioner is near the end of its useful life due to age and should be further investigated by a certified HVAC contractor prior to commitment.

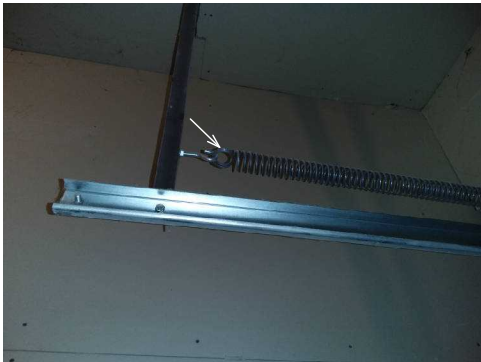
14. : Attached Garage Garage Doors: **Insulated metal** - No safety cables installed in springs. This is a safety issue that needs immediate attention to avoid personal injuries & property damage.

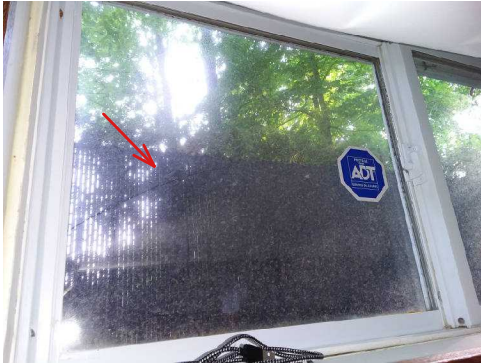
15. : Playroom / Family Room Living Space Windows: **Vinyl sliding - Cracked glass noted on the window above bar counter, Repairs required.**

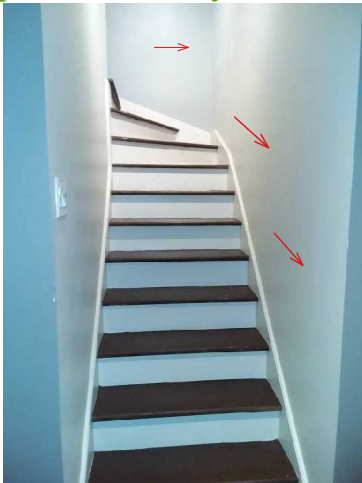
16. : Playroom / Family Room Living Space Basement Stairs/Railings: **Wood stairs - Missing hand railing for fall protection safety. This is a safety concern that needs immediate correction to prevent personal injuries.**

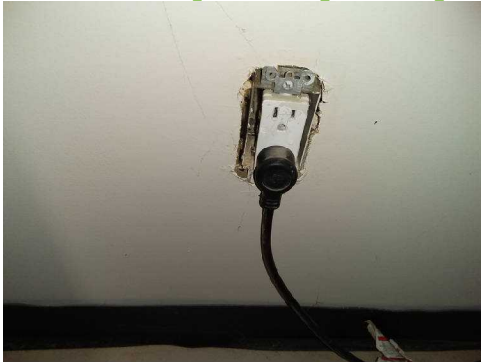
17. : Basement Utility Room Living Space Electrical: **120 VAC - Missing outlet/switch cover plates observed. Correction required to prevent personal injuries.**

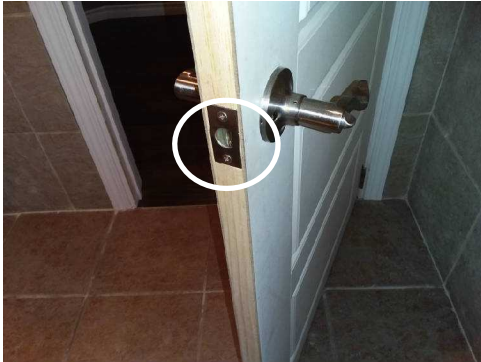
18. : Basement Powder Room Bathroom Doors: **Hollow wood** - **The door hardware sticks. Repairs / adjustment is required for proper door operation.**

Door stop missing. Install the missing door stop to prevent damage to adjacent finished surfaces.

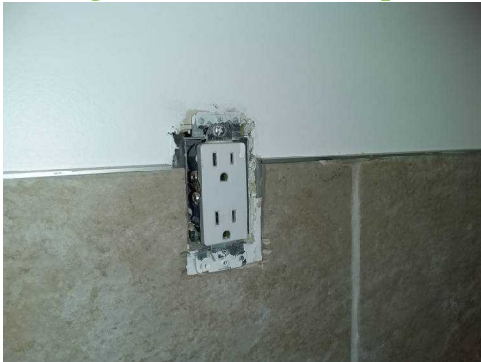
19. : Basement Powder Room Bathroom Electrical: **120 VAC** - **None GFCI outlet close to water source installed. It is recommended that GFCI protection is installed for any electrical outlet located within 1.5 m (5') of any sink. These safety devices should be tested regularly in accordance with the manufacturer's specifications.**

Missing outlet/switch cover plates observed. Correction required to prevent personal injuries.

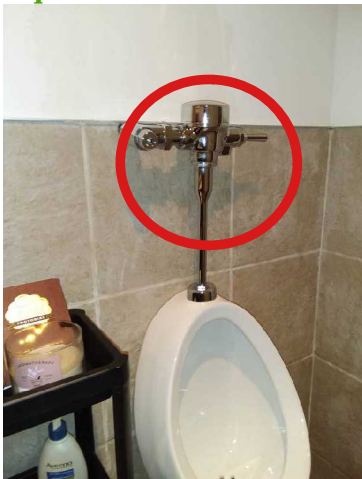
20. : Basement Powder Room Bathroom Spa Tub/Surround: **Urinal** - **Loose plumbing fixture observed. Repairs required.**

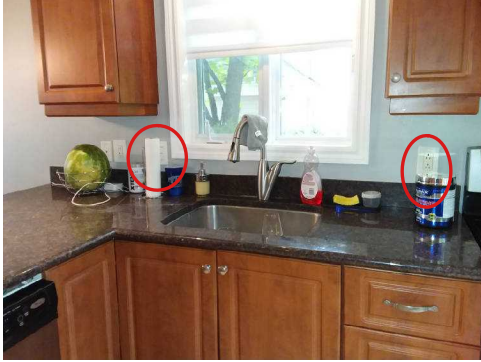
21. : Ground Floor Kitchen Electrical: **120 VAC** - None GFCI outlet close to water source installed. It is recommended that GFCI protection is installed for any electrical outlet located within 1.5 m (5') of any sink. These safety devices should be tested regularly in accordance with the manufacturer's specifications.

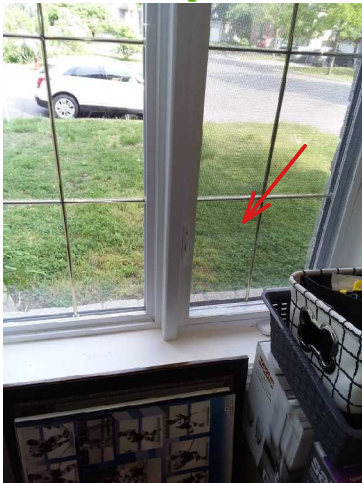
22. : Entrance / Hallway / Living-Dining Area Living Space Windows: **Vinyl casement** - Slight window fogging and moisture presence between glass panes noted due to damaged seals. Repairs required.

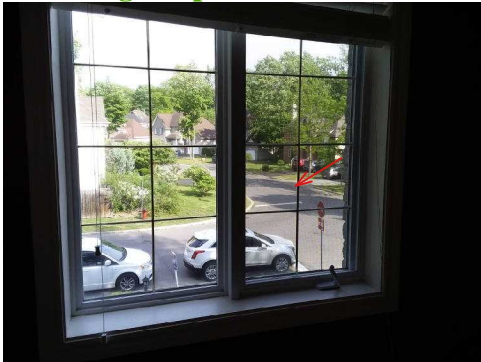
23. : 2nd Floor Mezzanine Living Space Windows: **Vinyl casement** - Window fogging and moisture presence between glass panes noted due to damaged seals. Repairs required.

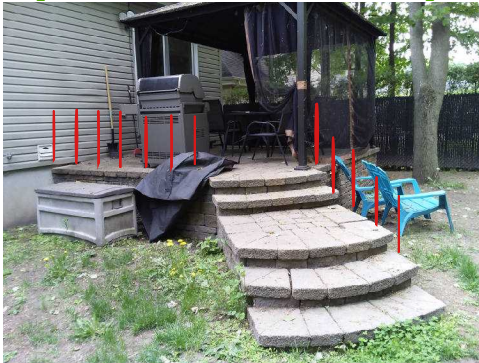
Deck: **Paving stone** - Safety railing missing around deck and steps, this is a safety issue that requires immediate correction to prevent personal injuries.

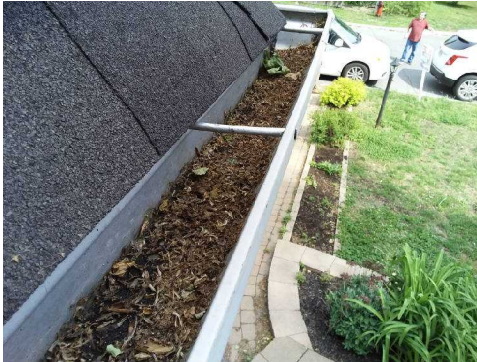
Gutters: **Metal - Found dirty. Immediate cleaning required for proper storm water drainage.**

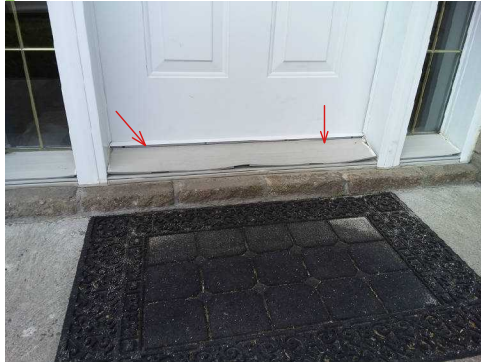
Entry Doors: **Hinged metal & glass** - **Damage to door sill observed. Repairs required to prevent water infiltration.**

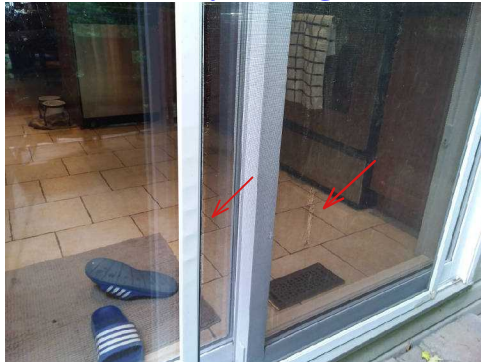
Patio Door: **Vinyl sliding** - **Screen damage / cuts noted. Repairs / replacement required.**

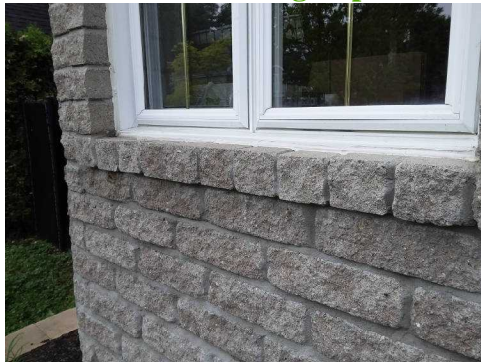
Window Sills: **Brick** - **Brick sills are prone to leak and damage. Recommend covering with a metal clad / flashing to prevent water infiltration and damage to framing wood.**

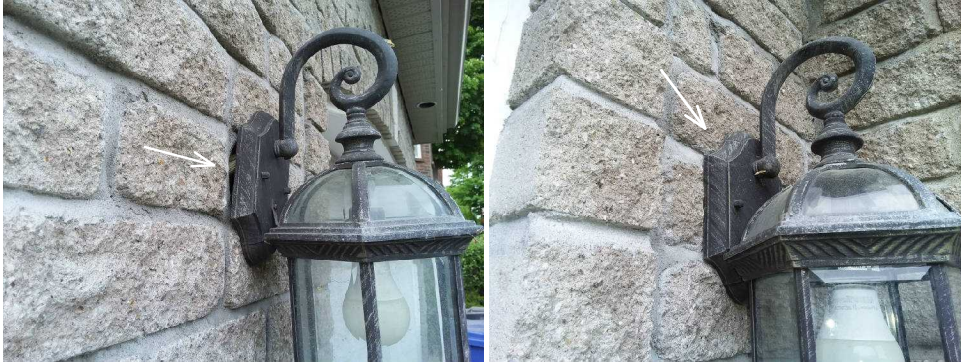
Exterior Lighting: **Surface mount** - **Light bases not caulked (weather proofed). Caulking required to prevent water infiltration & damage to wood structure behind.**

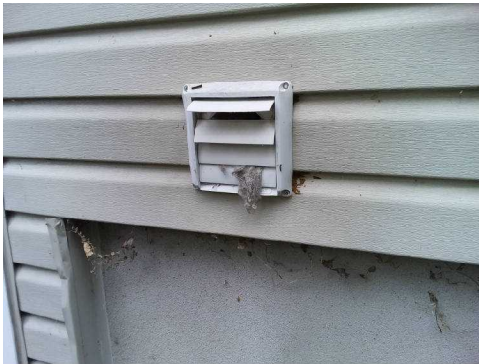
Dryer Outlet: **Exterior Grill - Lint build up noted at the exterior dryer vent. This is a fire hazard that needs immediate correction.**

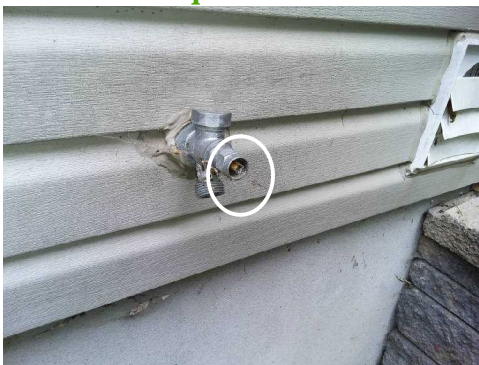
Hose Bibs: **Frost resistant (self draining type) - Missing / damaged handle noted, correction required.**

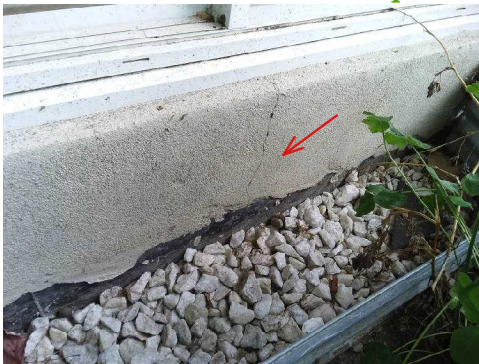
2. **Marginal** Foundation: Poured concrete - At least 1 crack noted. Immediate repairs by a certified foundation contractor is required to prevent water / insect intrusion into basement.

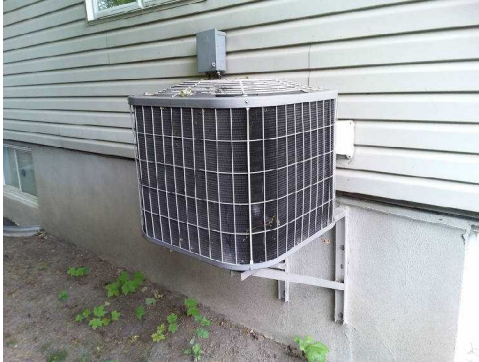
A/C System Operation: **Recommend replacement - Average life of an outside A/C compressor/condenser is approx. 15-18 years. In the inspectors opinion the 17 year old air conditioner is near the end of its useful life due to age and should be further investigated by a certified HVAC contractor prior to commitment.**

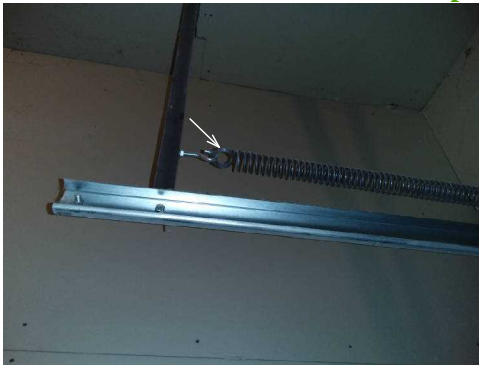
Garage Doors: **Insulated metal** - No safety cables installed in springs. This is a safety issue that needs immediate attention to avoid personal injuries & property damage.

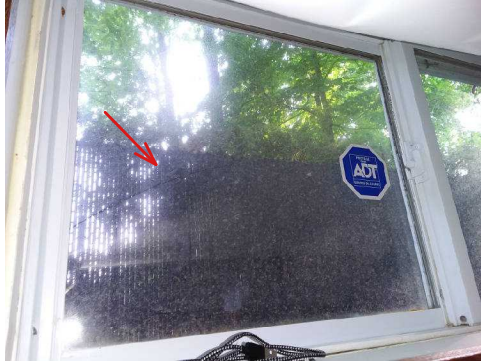
Windows: **Vinyl sliding** - **Cracked glass noted on the window above bar counter, Repairs required.**

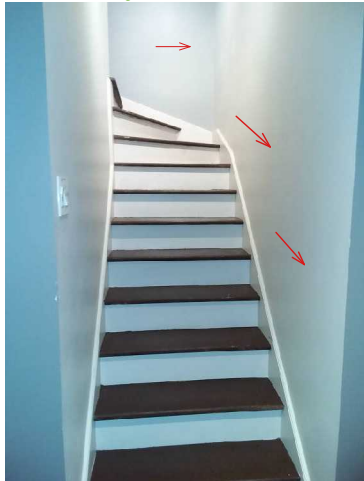
Basement Stairs/Railings: **Wood stairs** - **Missing hand railing for fall protection safety. This is a safety concern that needs immediate correction to prevent personal injuries.**

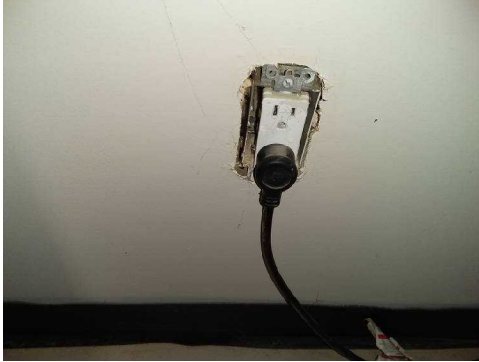
Electrical: **120 VAC - Missing outlet/switch cover plates observed. Correction required to prevent personal injuries.**

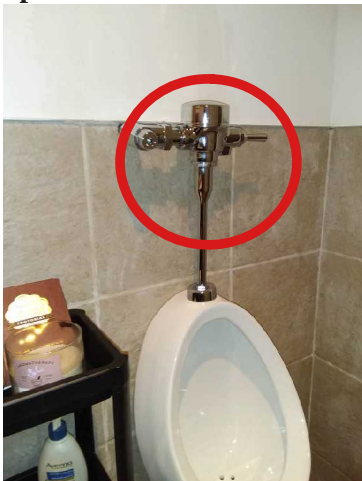
Spa Tub/Surround: **Urinal - Loose plumbing fixture observed. Repairs required.**

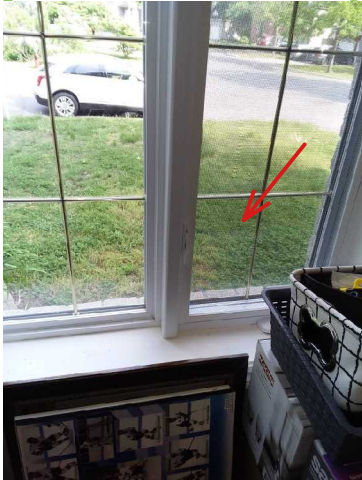
Windows: **Vinyl casement - Slight window fogging and moisture presence between glass panes noted due to damaged seals. Repairs required.**

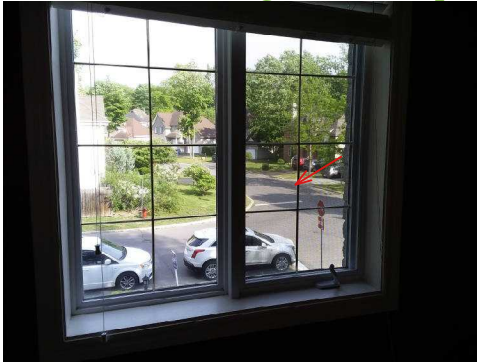
Windows: **Vinyl casement** - Window fogging and moisture presence between glass panes noted due to damaged seals. Repairs required.
