Pre-Purchase Inspection Report

100 Street Avenue
Town, QC H0H 0H0

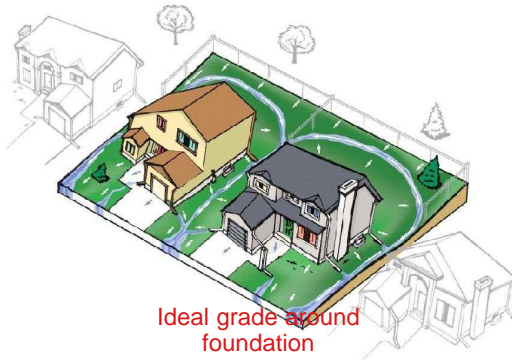
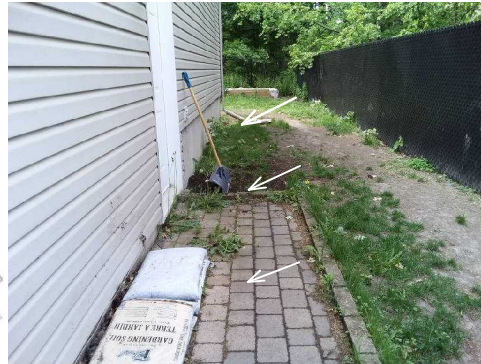
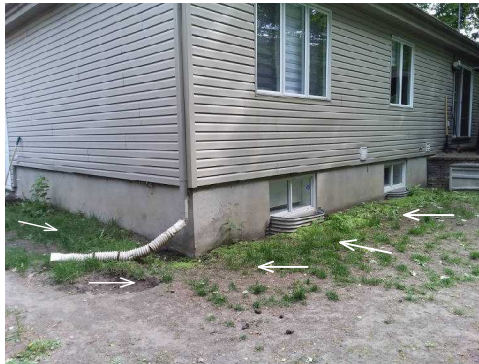
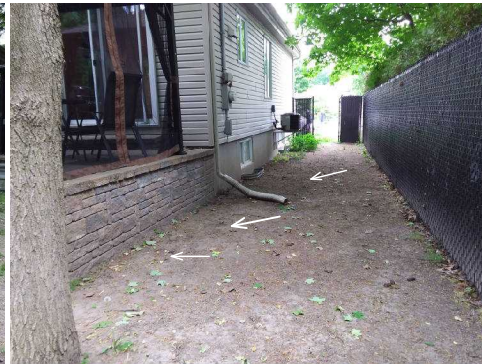
Grading: **Negative slope observed** - Negative grade slope noted on the Left, Right sides and rear. Immediate build up of positive grade slope (1 inch per foot for 6' from the foundation) is required to divert storm water away from the foundation and prevent water infiltration and damage to basement area.

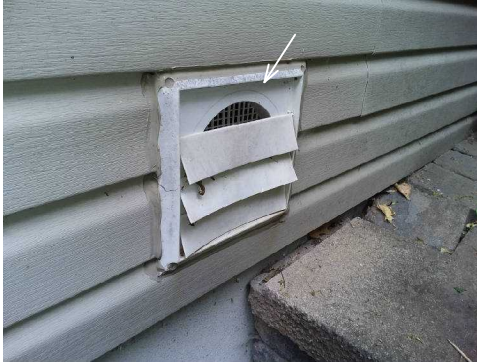
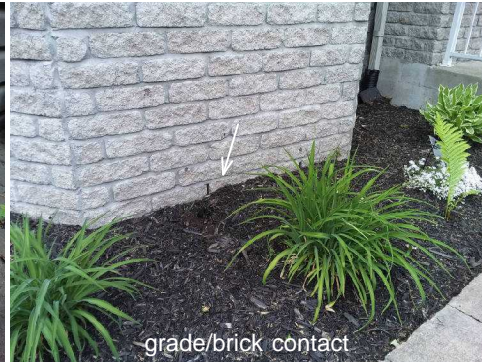
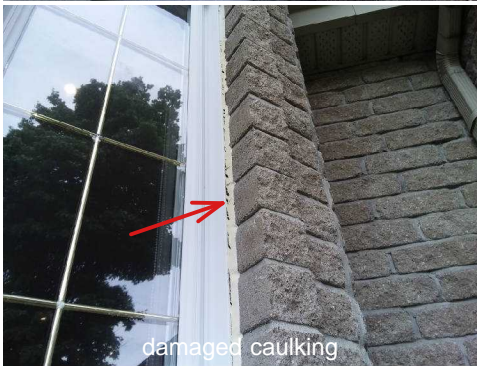
Type: Brick veneer, Vinyl siding - Flappers - Exterior flaps found damaged. Repairs required to prevent water intrusion.

Brick contact with soil noted at front flower bed. This condition must be immediately further investigated / corrected by a certified contractor to prevent further damage and deterioration to the wood framing behind the walls.

Caulking is breaking up around windows. Immediate re-caulking is required to prevent further water infiltration / damage to framing behind.

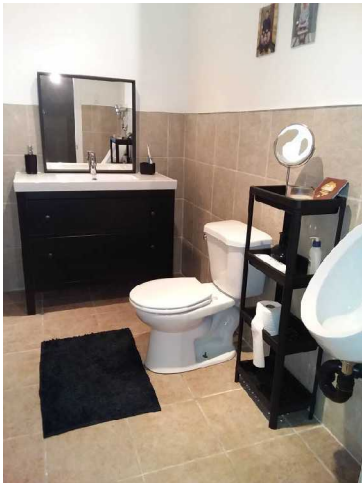
11. **Acceptable** Ventilation: **Electric ventilation fan**
12. **Acceptable** HVAC Source: **Forced Air**
: Basement Powder Room Bathroom
13. **Acceptable** Ceiling: **Painted drywall/plaster.**
14. **Acceptable** Walls: **Paint & tiles**
-

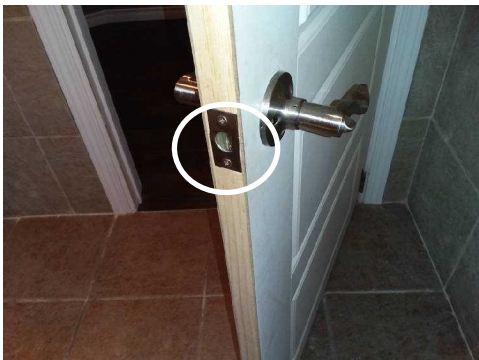
15. **Acceptable** Floor: **Ceramic tile**
16. **Marginal** Doors: **Hollow wood - The door hardware sticks. Repairs / adjustment is required for proper door operation.**

Door stop missing. Install the missing door stop to prevent damage to adjacent finished surfaces.

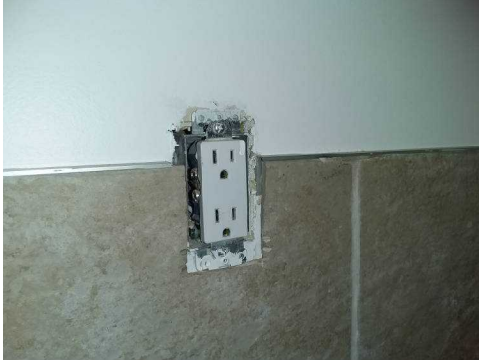
17. **Marginal**

Electrical: **120 VAC - None GFCI outlet close to water source installed. It is recommended that GFCI protection is installed for any electrical outlet located within 1.5 m (5') of any sink. These safety devices should be tested regularly in accordance with the manufacturer's specifications.**

Missing outlet/switch cover plates observed. Correction required to prevent personal injuries.

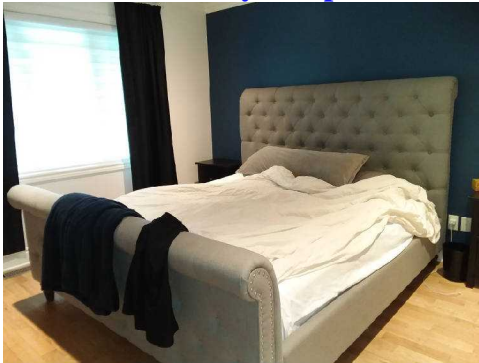
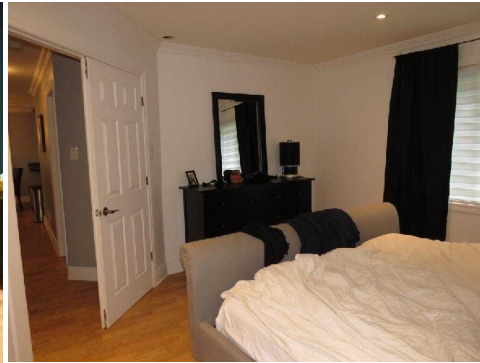
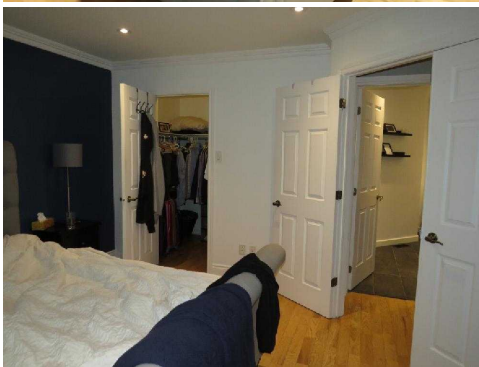
- 4. Acceptable
- 5. Acceptable
- 6. Acceptable
- 7. Acceptable
- 8. Acceptable
- 9. Not Present

Floor: Wood
Doors: Hollow core wood
Windows: Vinyl casement
Electrical: 120 VAC
HVAC Source: Forced Air
Smoke & CO Detectors: None installed

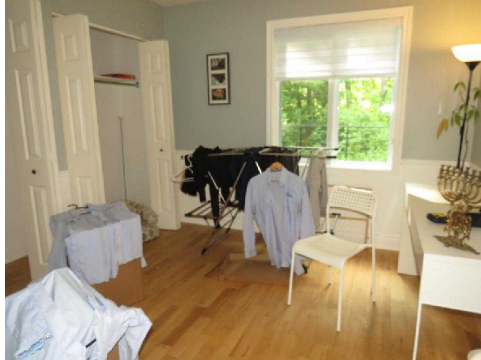
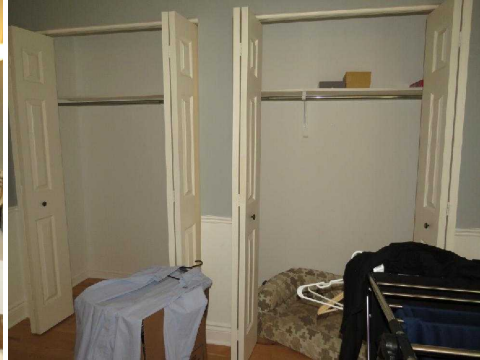
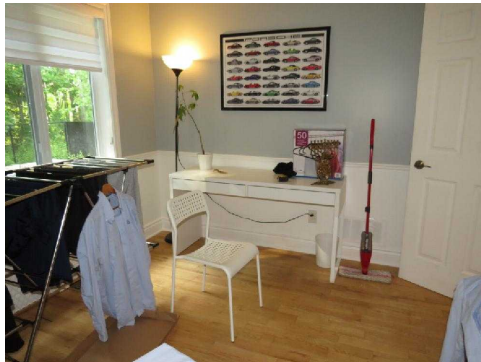
Walls: **Painted drywall/plaster.**

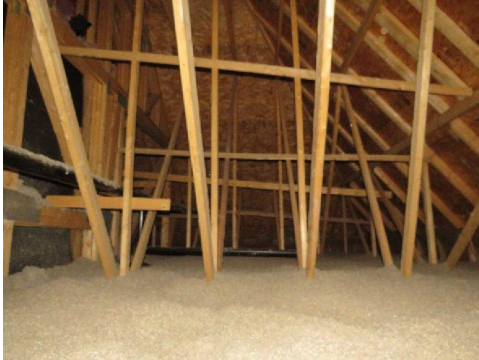
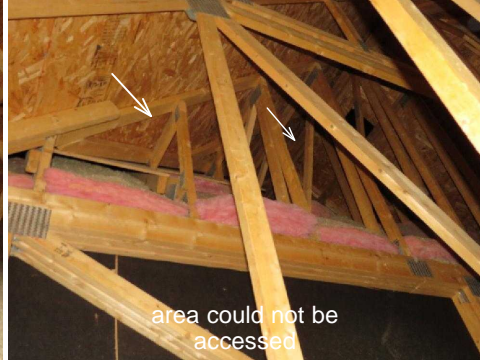
Roof Framing: **Trusses**

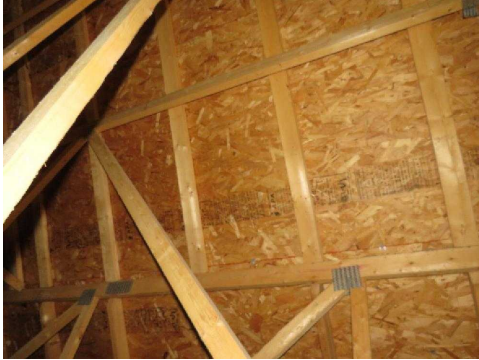
Sheathing: **OSB (Oriented Strand Board)**

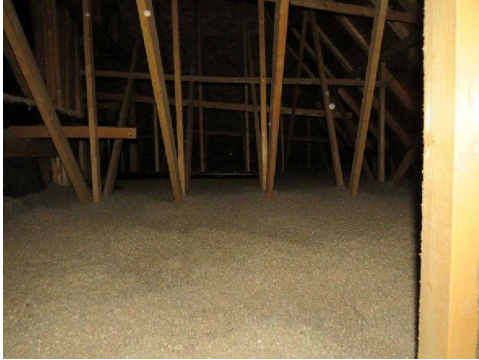
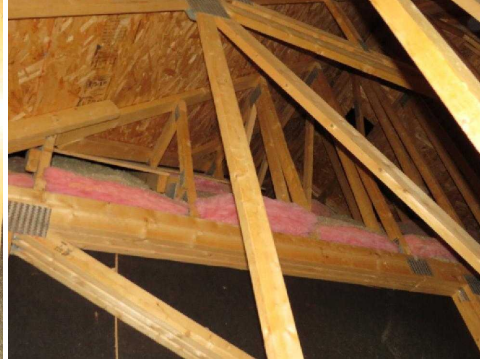
Insulation: **Blown Cellulose, Fiberglass**

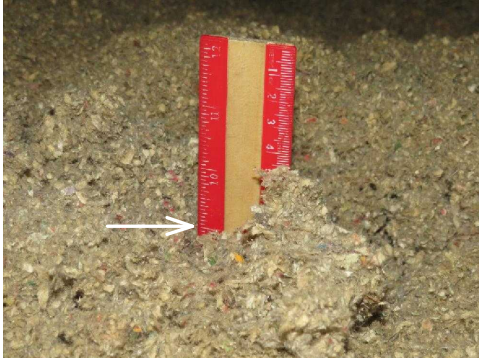
Insulation Depth: **Approximately 9"**
